INVESTIGATION OF THE SERVICE RECORD
AND
EXPLOSION HAZARD
OF CHEMICAL FIRE EXTINGUISHERS
BY
N. F. KIMBALL

A THESIS

ARMOUR INSTITUTE OF TECHNOLOGY

MAY 31, 1917

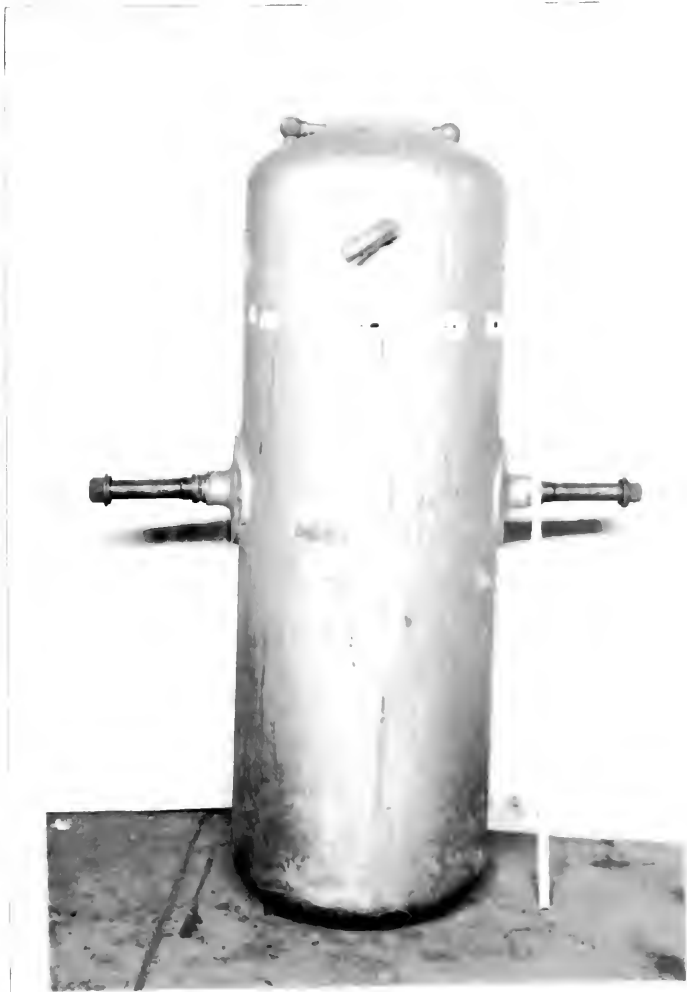
Fig. 1.

as the holes were. The general appearance of the device is shown by Figure 1.

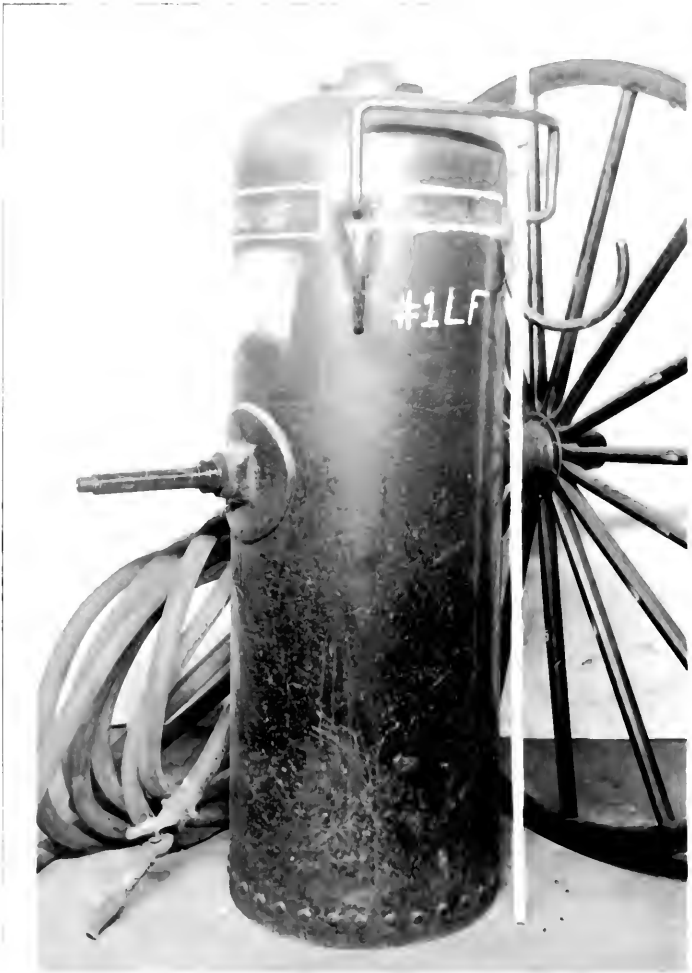
Fig. 3.

the shell; one band extending between the hose supporting brackets; and the other, the rest of the way around the tank. The general appearance of the device is shown by Figure 3.

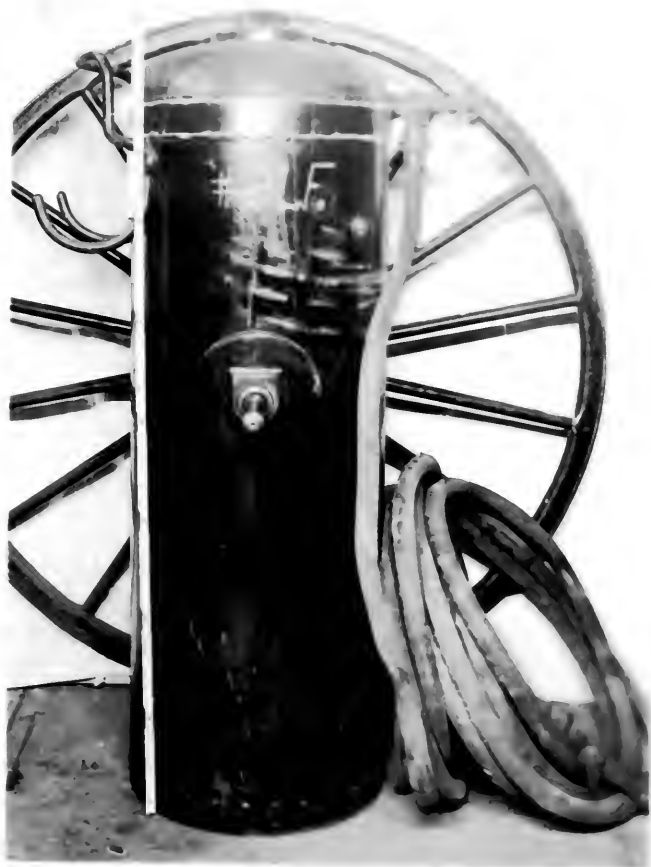
Fig. 4.

Machine No. 20.- This extinguisher had three holes in the shell, observing from the inside, ranging in size from a pin hole to 3/16 by 1/2 inch. The tank was heavily incrustated on the inside at the filling level. Two bands were soldered to the outside of the tank at the solution level, each band extending half way around the tank. The general appearance of the device is shown by Figure 4.

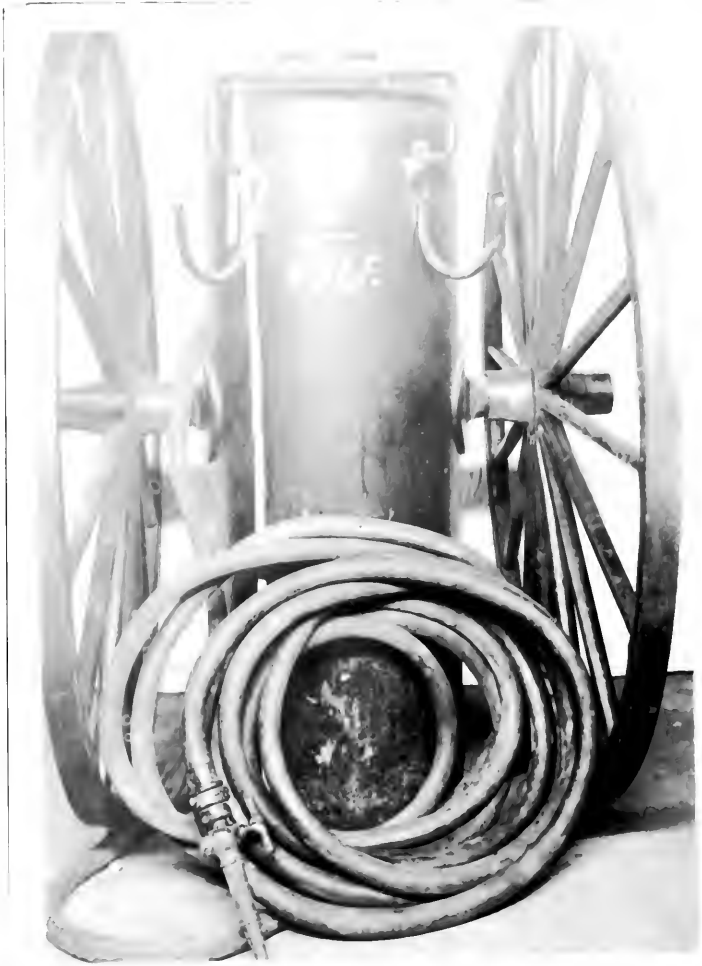
Fig. 5.

Machine No. 30.- This extinguisher had two lead plugs near the hose supporting brackets and on a line just above these brackets. A heavy incrustation was found on the interior of the tank at the filling level. The general appearance of the device is shown by Figure 5.

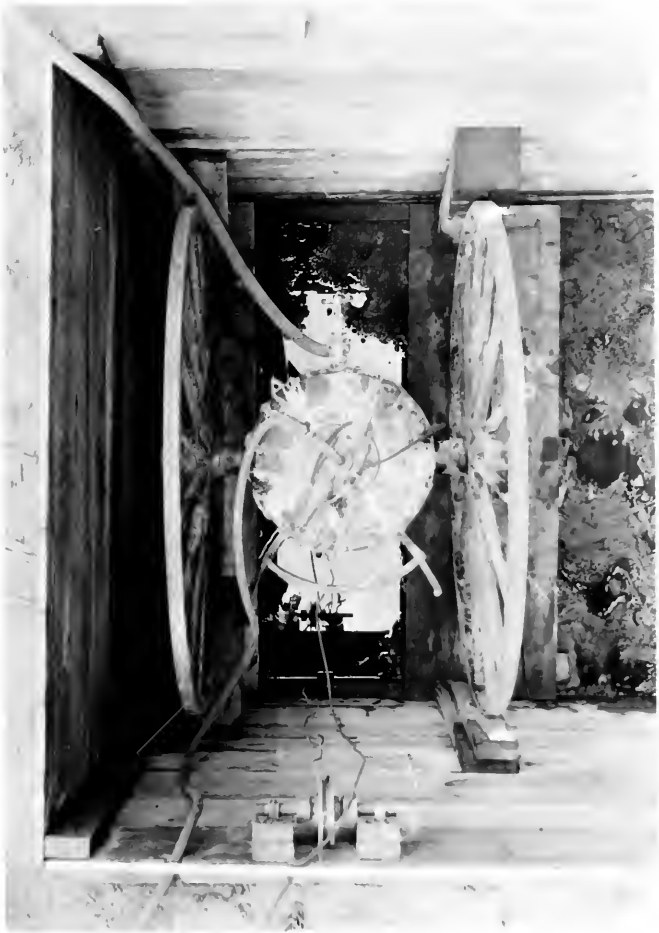
Fig. 6.

In order that the extinguishers might be operated with safety, they were placed in a pit 5 feet square and 5 feet deep, the top of which was covered with a heavy two-ply door, weighted down with sand bags. The tanks were placed in operation; that is, operated, by means of a cord running over a system of pulleys and passing out through an opening in the top of the pit.

The pressures generated in the tanks were read on a pressure gauge, located at some distance from the pit, and connected to the tanks by means of patrol hose; the connection at the tank being made at a topped opening provided in the cap of each device. The patrol hose was brought out through an opening in the pit.

Figures 6 and 7 show an extinguisher in the pit before and after inverting. The

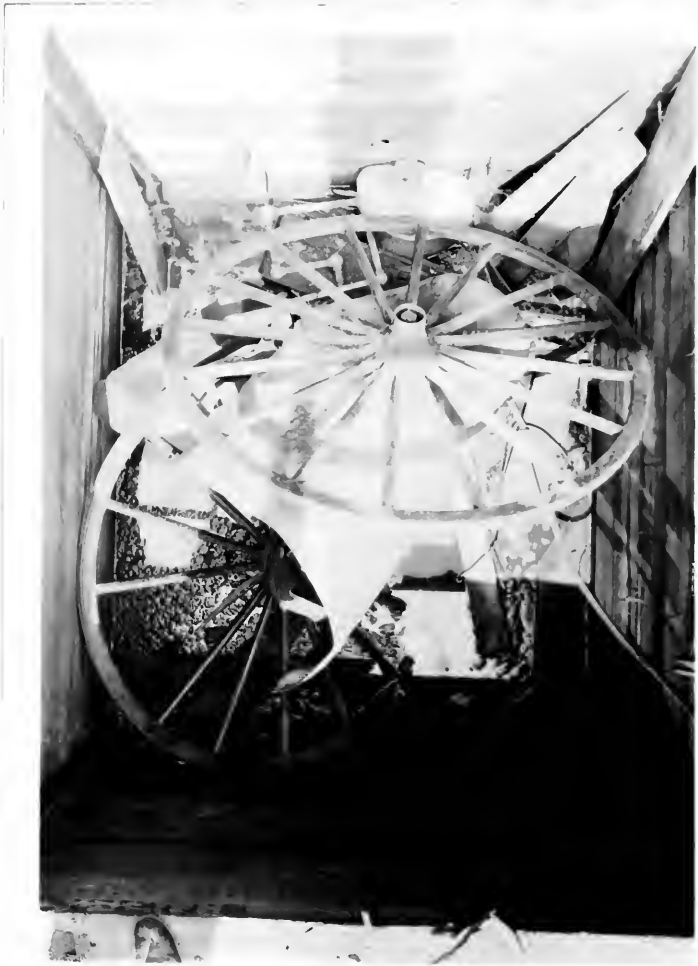
Fig. 8.

The shell was completely wrecked, being split from top to bottom. The bottom was intact and fell down inside the shell; the acid receptacle also burst, due apparently to internal pressure in the receptacle.

Figures 8, 9, 10, 11, 12, and 13, show the extinguisher after the wrecking of the shell. In Figures 9 and 10 the bottom can be seen as it

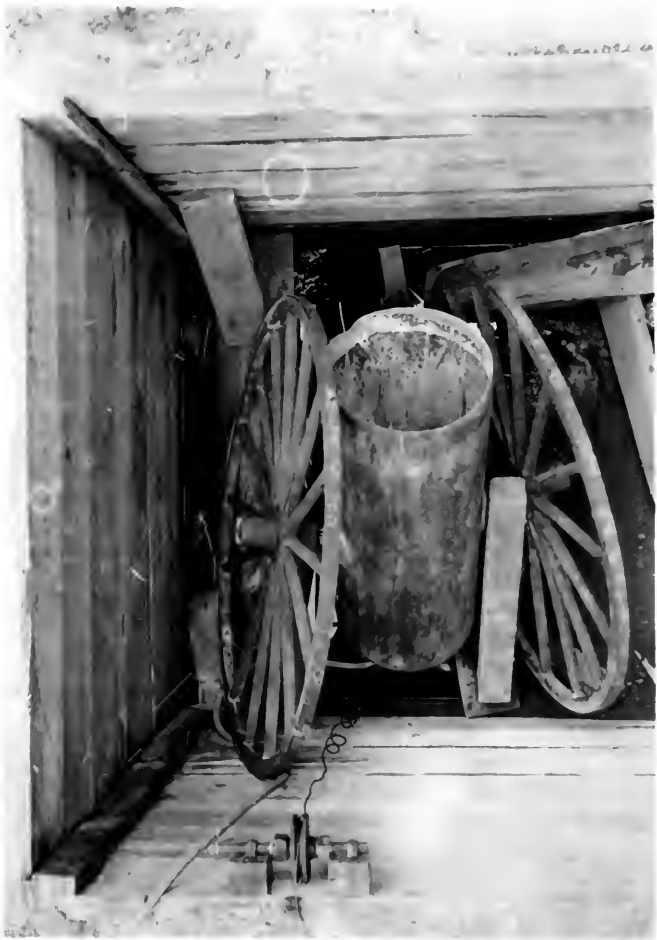
Fig. 14.

The recoil tore one axle out of the flange casting and bent the other axle. Figure 14 shows the extinguisher in the pit, just as it appeared after the test. Figure 15 shows the scratches on the sides of the bottom head, and Figure 16, the scratches on the inside of the shell which were made by the bottom as it was forced out of the shell. Figure 17 shows the extinguisher as it appeared set up in the yard. The bottom and acid receptacle are shown between the wheels.

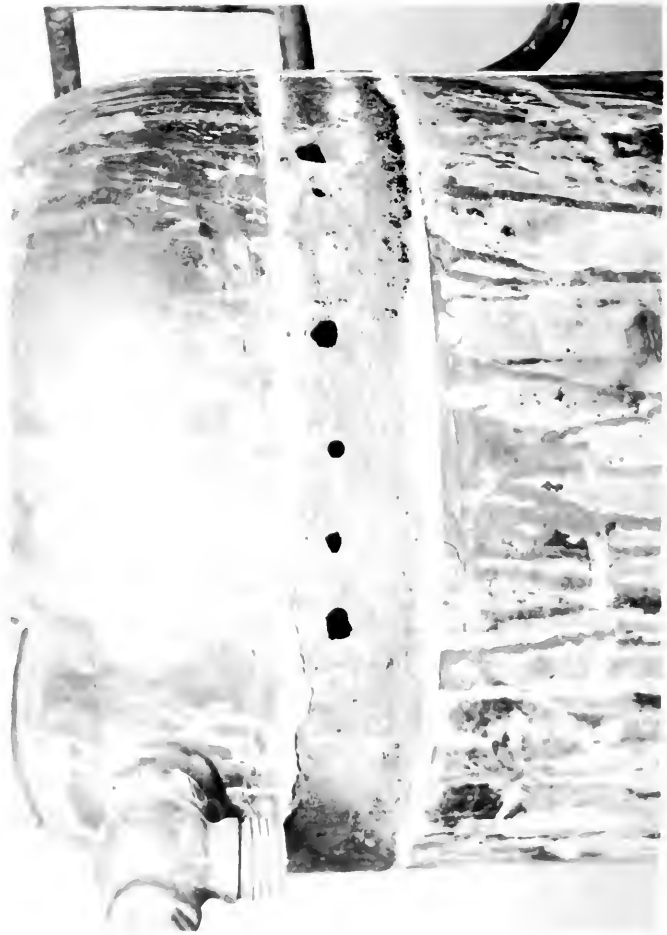
Fig. 18.

A new crack developed at the bottom of the band just opposite the soldered place at the top of the band. All of the pressure escaped in 130 seconds. The bands were then taken off and the holes plugged, to ascertain whether this method of repairing the tank was more effective than the former. Figures 18, 19, and 20 show the holes in the shell after the bands were removed. Twenty-three holes were found in the shell after the bands were removed.

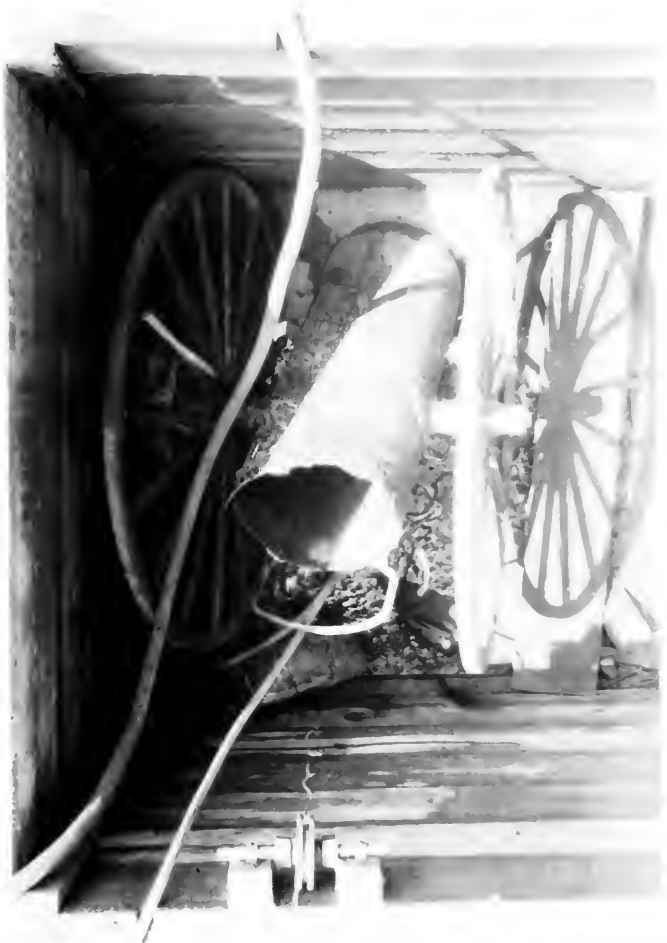
Fig. 21.

In this test the stopple was taken out of the acid receptacle. The recoil blew the tank up against the wooden door covering the pit, leaving an imprint of the bottom on the door. Figures 21, 22, and 23 show the tank in the pit and after it was set up in the yard. The pictures show clearly the ragged edge at the break, indicating how the shell was weakened by corrosion, the metal being eaten al-

most entirely away practically all around the shell.
